# ELEEK

LIGHTING RESTORATION AND HISTORICAL REPLICATION

# portland art museum case study

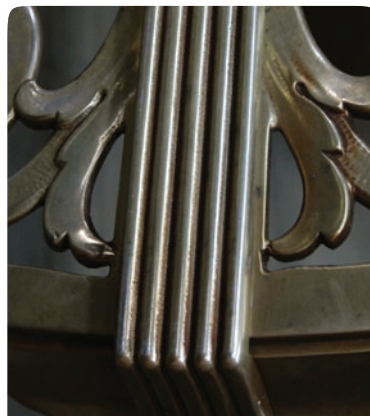
Fixture Before Restoration

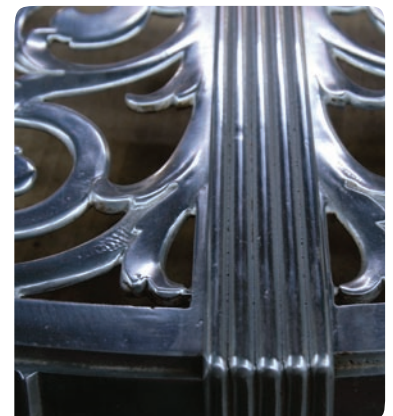
After Restoration

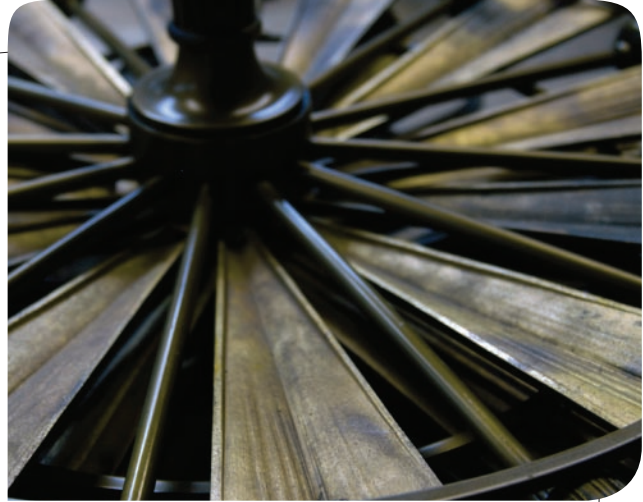
Detail of chandelier before restoration

- All parts were stripped down to bare metal and refinished with a historically accurate finish.
- All electrical components were replaced to comply with UL specifications.

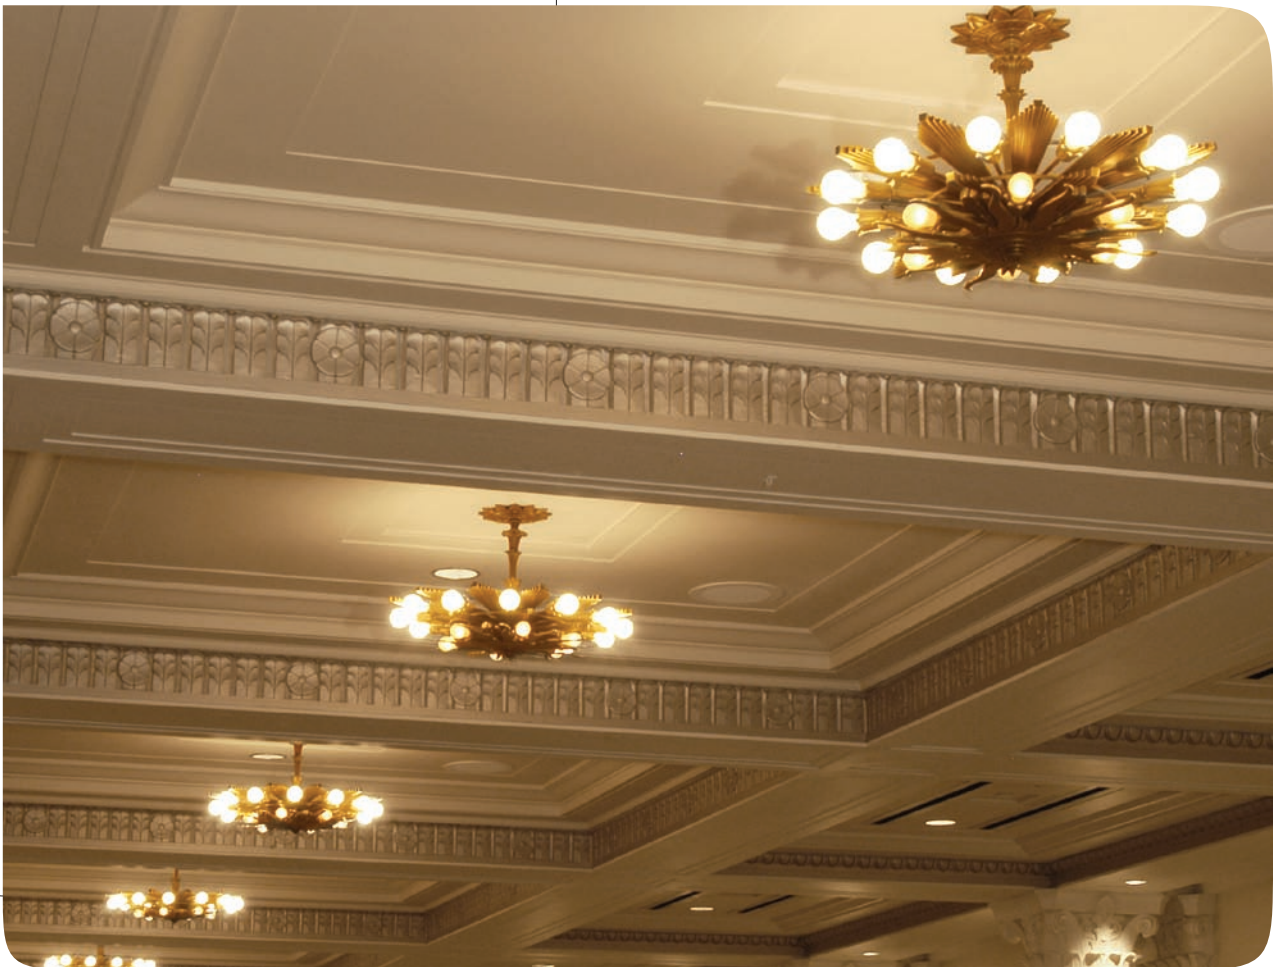
Restored and reinstalled chandeliers

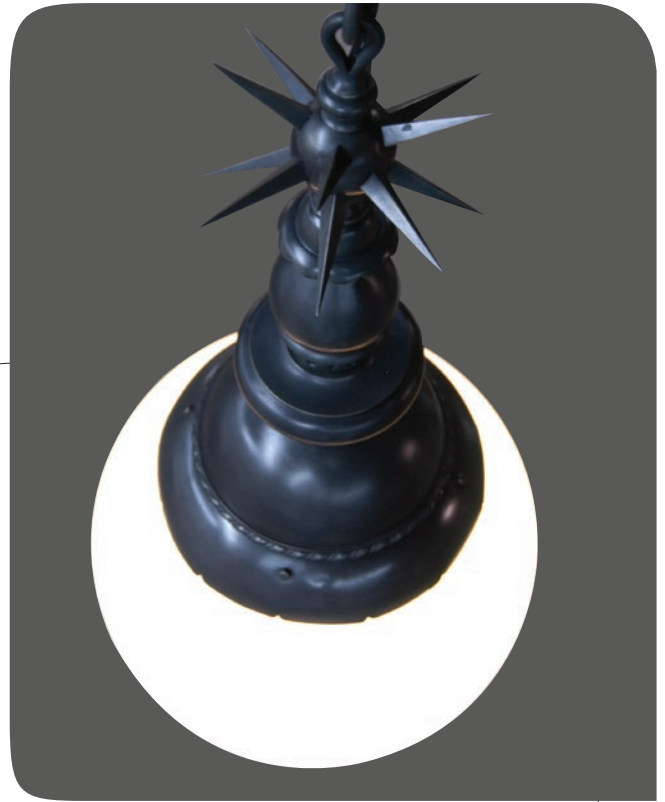
Restored & Rebuilt pendant

- All parts were stripped down to bare metal and refinished with a historically accurate finish.
- All electrical components were replaced to comply with UL specifications.
- Historically accurate glass globes and tassels were sourced and replaced.

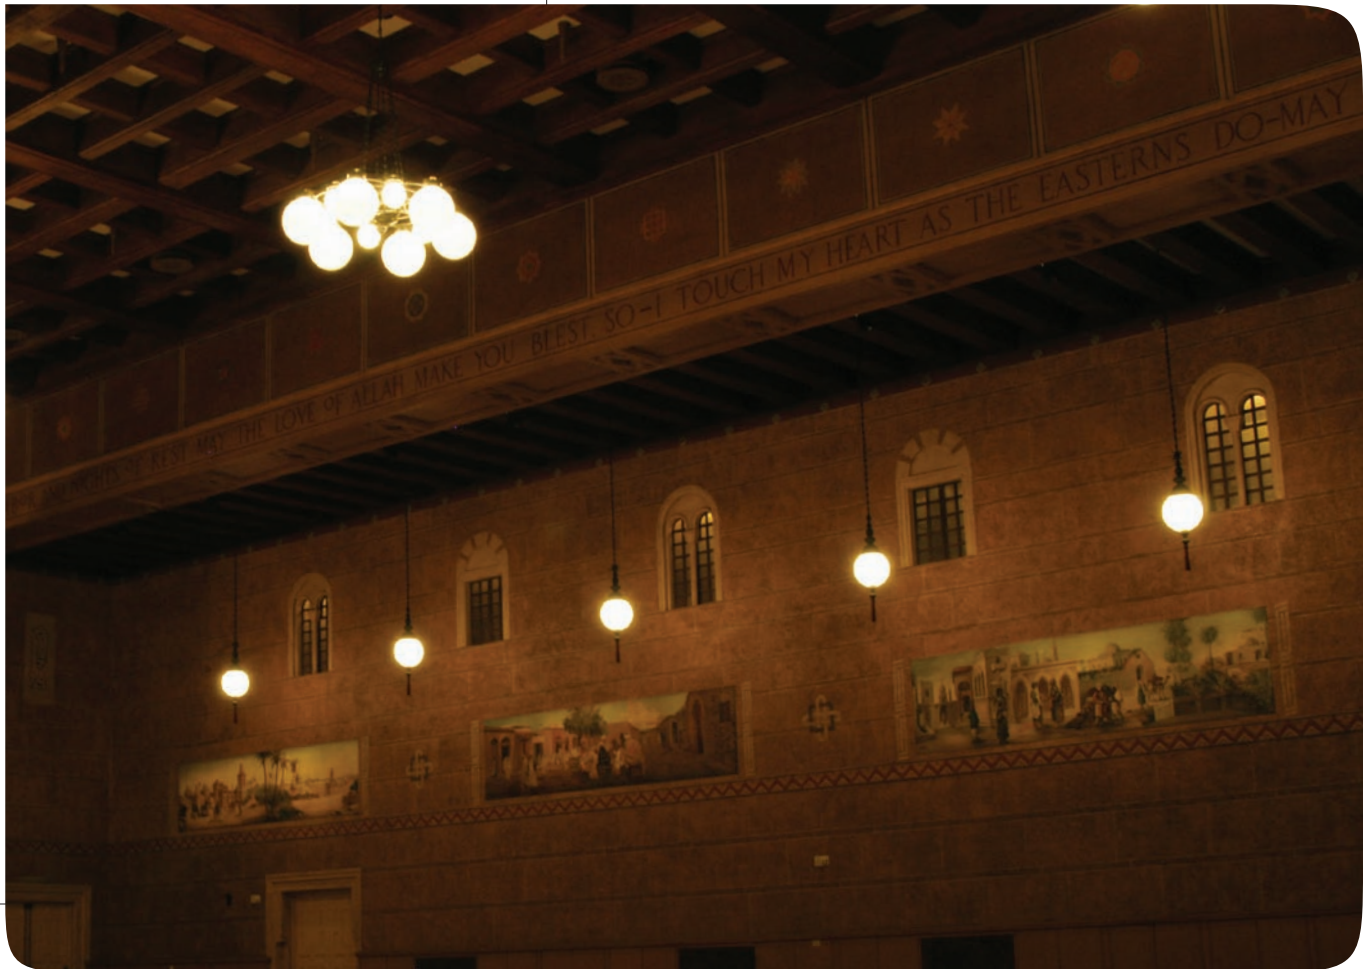
Restored pendants installed

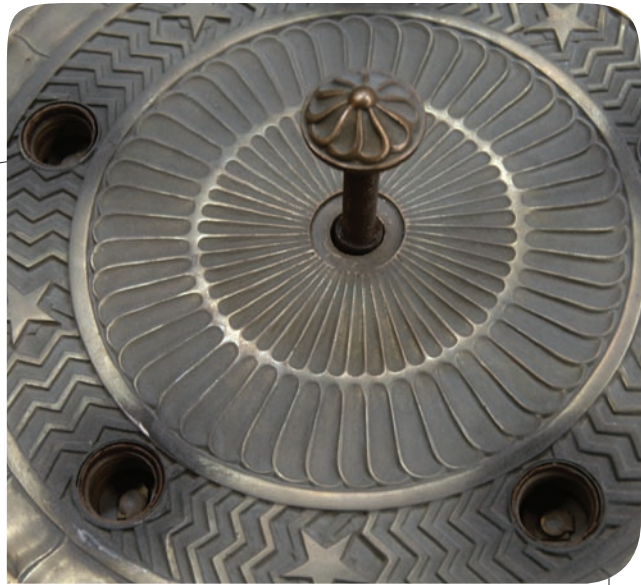
Fixture Before Restoration

- All parts were stripped down to bare metal and refinished with a historically accurate finish.
- All electrical components were replaced to comply with UL specifications.

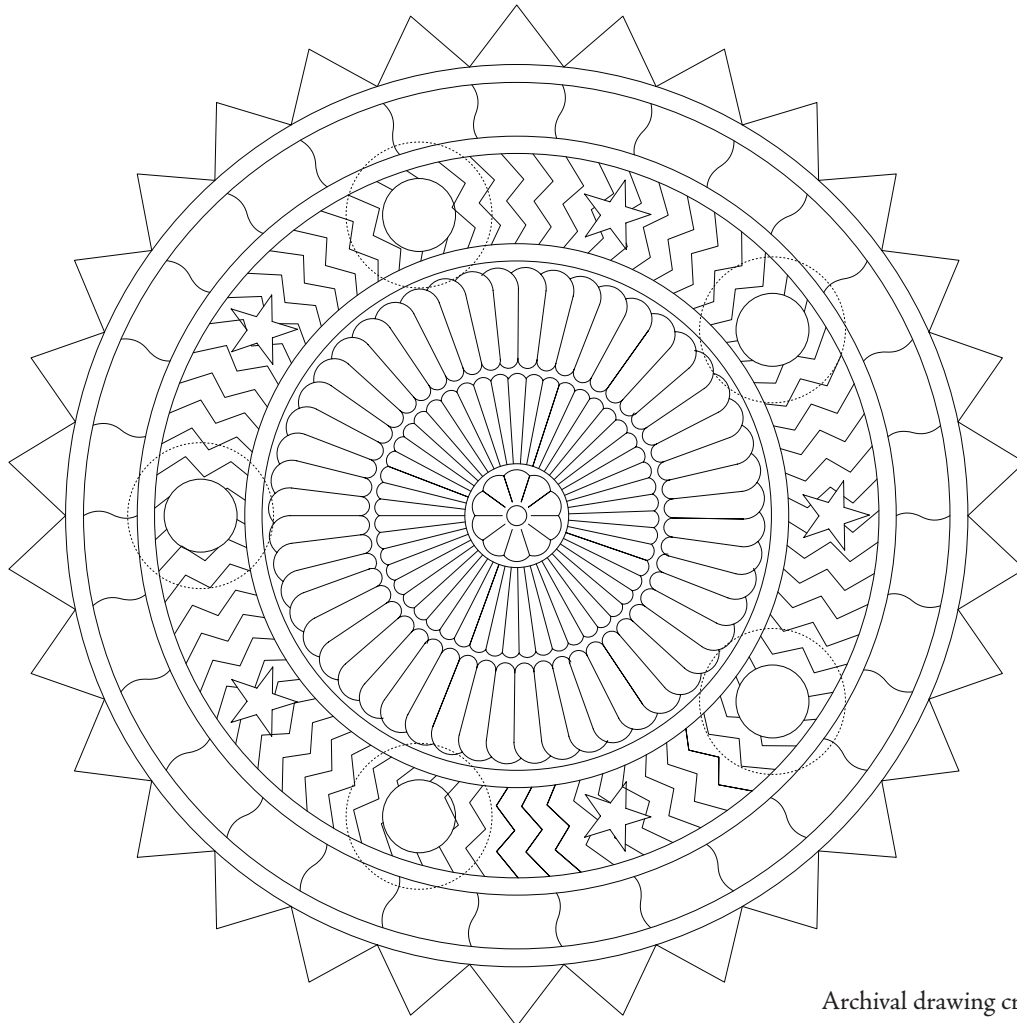
Archival drawing created by Eleek

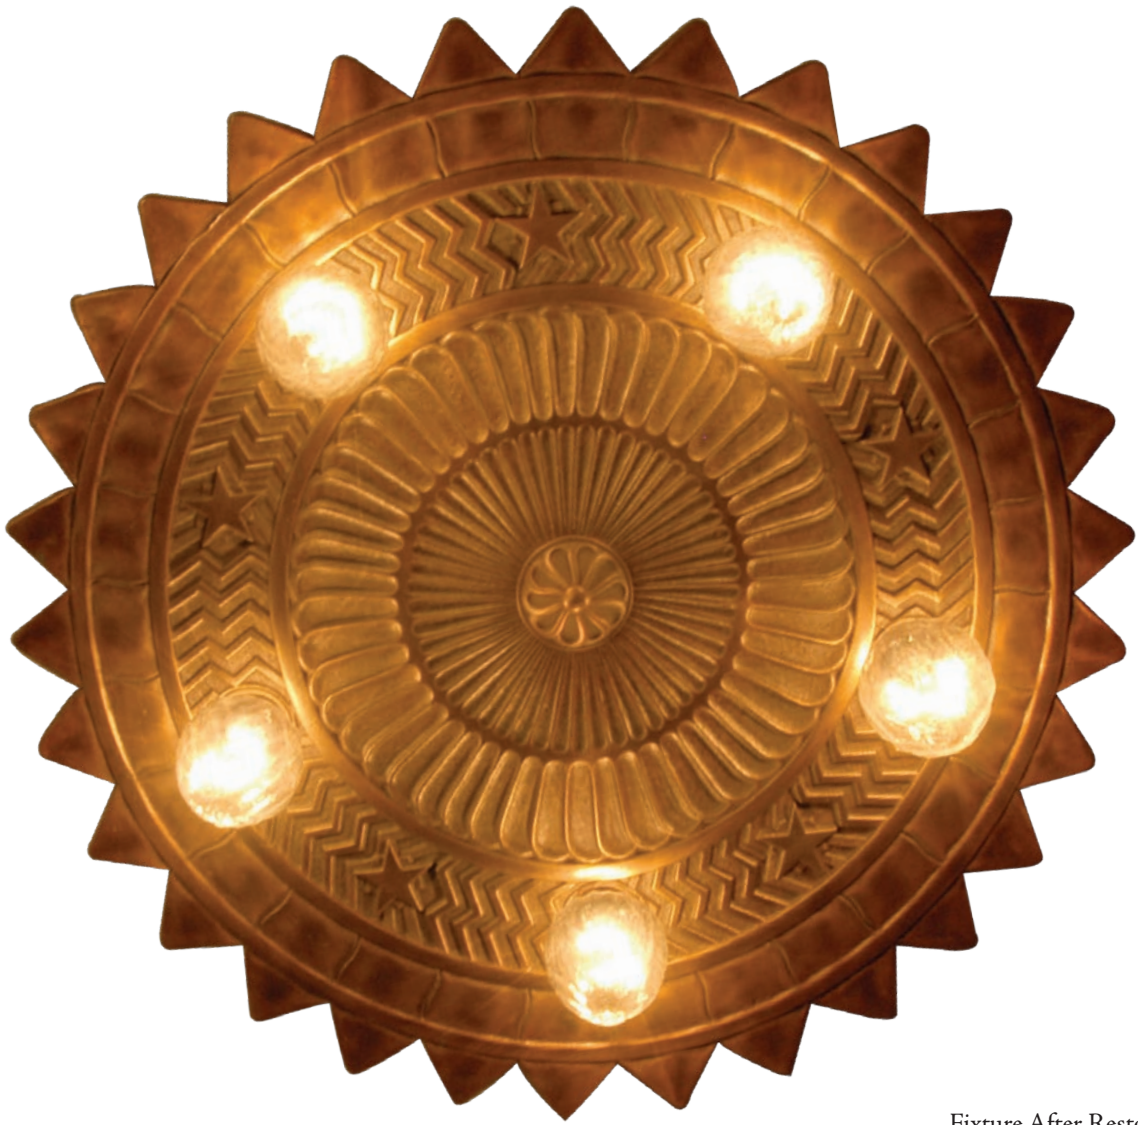
Fixture After Restoration

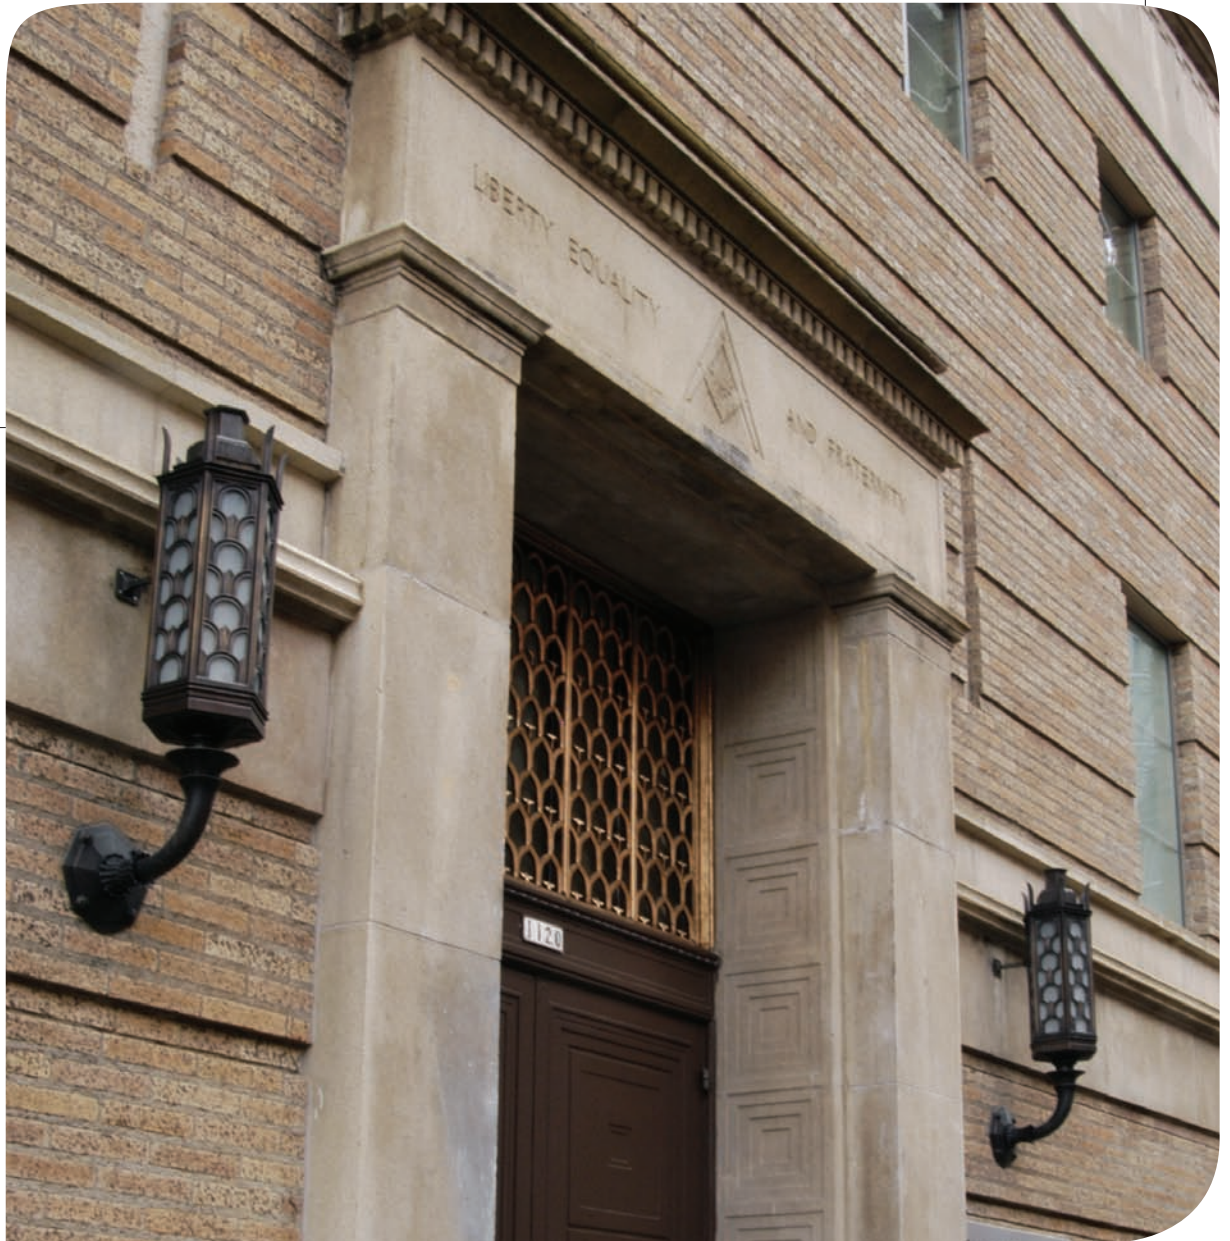
Restored Sconces outside of the Portland Art Museum
